April 1945 as  
Advance Confidential Report L5C24

SUMMARY OF MEASUREMENTS IN LANGLEY FULL-SCALE TUNNEL

OF MAXIMUM LIFT COEFFICIENTS AND

STALLING CHARACTERISTICS OF AIRPLANES

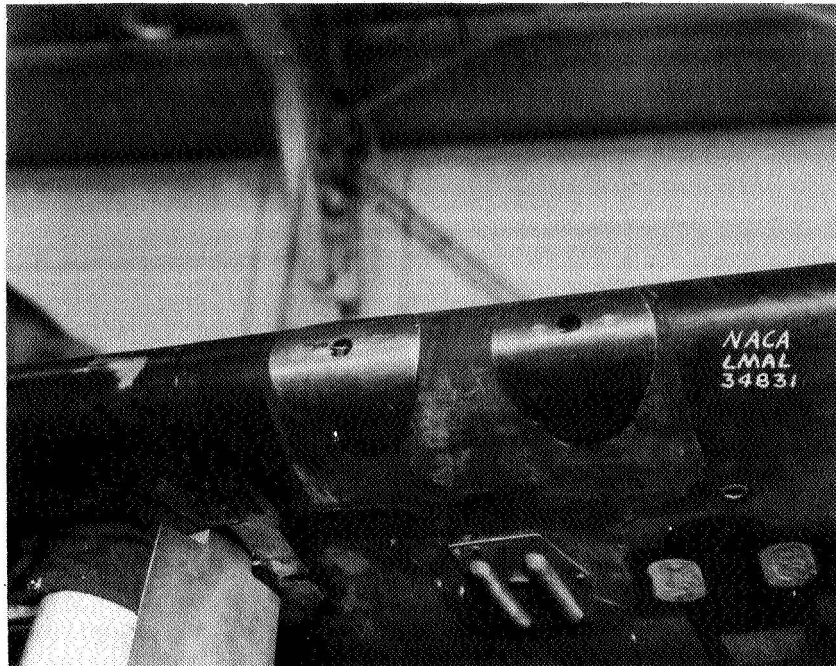
(a) Wing gun cover plates installed.

(b) Wing gun cover plates removed.

Figure 28.- Wing gun ports on airplane 1.
